Giant cell tumor formation due to metallosis after open latarjet and partial shoulder resurfacing

Matthew Wolfson,¹ Patrick Curtin,² Emily J. Curry,³ Sandra Cerda,⁴ Xinning Li¹

Abstract

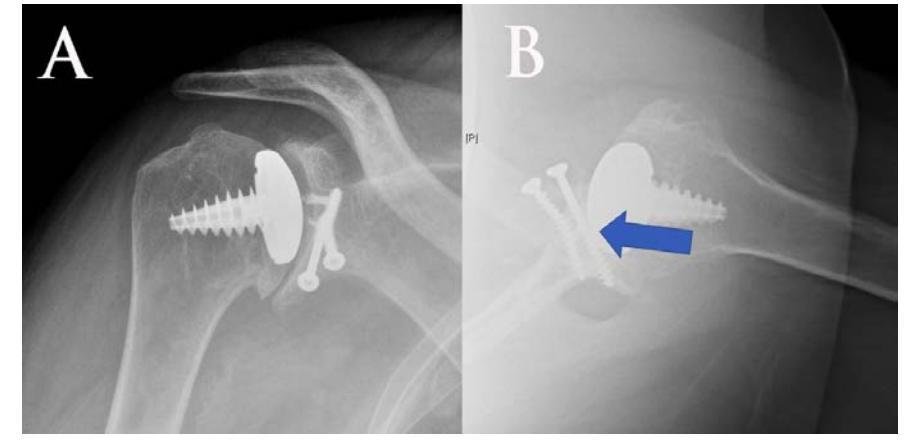
Figure 1. A. Right shoulder AP radiograph shows the partial resurfacing and two screws from the previous Latarjet surgery. There is also advanced stage glenohumeral arthritis. 1B. Axillary radiographic view of the right shoulder shows humeral head medialization and glenoid wear. The metal component of the partial shoulder replacement is in contact with the shaft of one of the screws from the Latarjet procedure (blue arrow).

Plain right five-view (AP, Grashey, axillary, external rotation and scapular-Y) shoulder radiographs displayed two screws within the glenoid, humeral head resurfacing, glenohumeral osteophytes and osseous densities in the axillary recess (Figure 1A and 1B). MR arthrogram and CT showed a chronic full thickness subscapularis tendon tear, retraction to the level of the glenoid, grade IV Goutallier fatty infiltration, a large nonspecific joint effusion in the anterior inferior axillary recess and glenoid flattening with osteoarthritis. She had an ESR 13 mm/hr, CRP 5.4 mg/L and WBC of 10.9 K/uL. Ultrasound-guided aspiration was held for 3 weeks and was negative for any bacterial growth or P. Acnes.

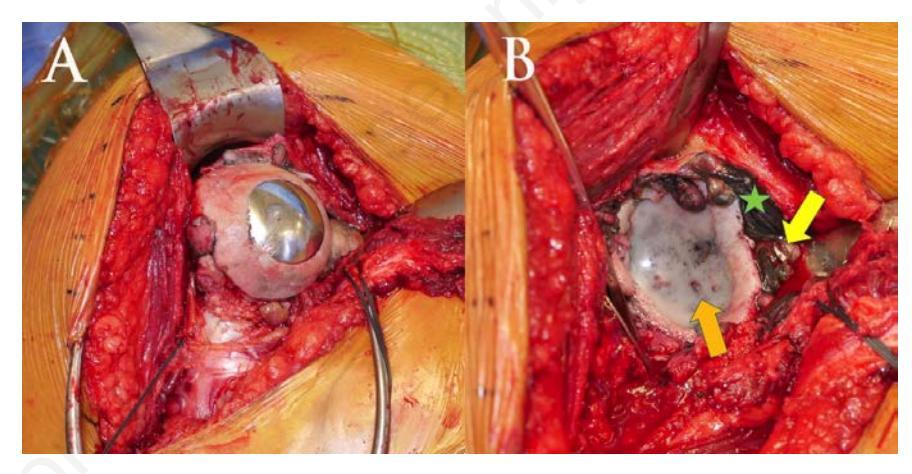
Figure 2. A. After exposure of the shoulder, partial shoulder resurfacing is seen with humeral head osteophytes. B. Dark tissue is above the anterior superior glenoid rim (green star) and the shaft of the screws is exposed (orange arrow) in the glenoid from the medial wear pattern. The yellow arrow shows the screw head.

side). Load and shift test were 2+ anterior, 1+ posterior and 1+ inferior. After sterile prepping and draping, a deltopectoral incision was made. Upon dissection, the subscapularis was absent and the capsule was thickened. The partial resurfacing was seen along with osteophytes on the humeral head (Figure 2A). A dark tissue was encountered within the glenohumeral joint (Figure 2B) and sent to pathology. The glenoid had exposed metal anchors which were subsequently removed. Additionally, there was humeral head medialization and medial wear on the glenoid exposing the shaft and one of the screws from the Latarjet procedure (Figure 2B). All hardware was removed and the patient was revised to a total shoulder arthroplasty (Figure 3A). The pectoralis major tendon was transferred just lateral to the lesser tuberosity (Figure 3B). Postoperatively, she was non-weight bearing in a sling with no external rotation past 20 degrees for 6 weeks. Standard postoperative physical therapy protocol was started. The two samples sent to surgical pathology were Specimen A (3.1x2.1x1.5cm tan-pink and tan-yellow nodule) which was a giant cell

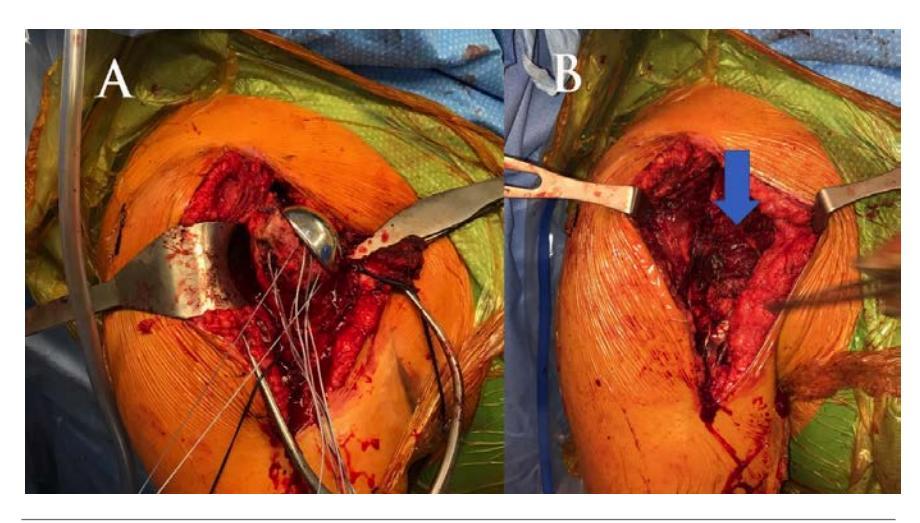
Figure 3. A) Hardware removal and conversion to a total shoulder replacement. 3B. Full pectoralis major transfer is seen here with the blue arrow.

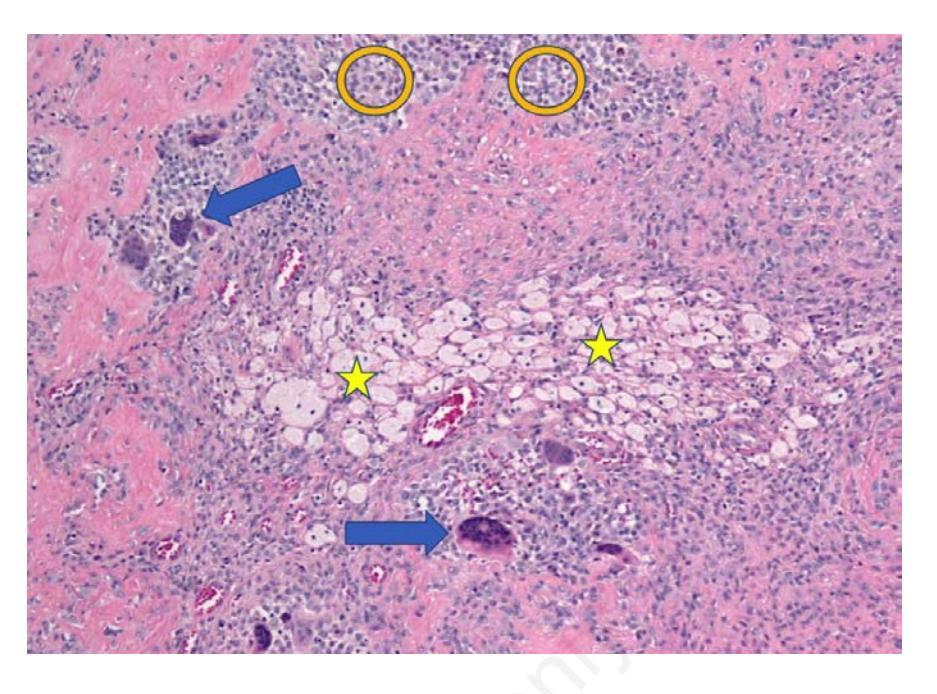
Figure 4. Histology H&E staining at 100x shows giant cell tumor formation in the soft tissue with the typical admixture of mononuclear cells, foamy macrophages (yellow star) and lymphocytes (orange circle) with scattered multinucleate giant cells (blue arrows).

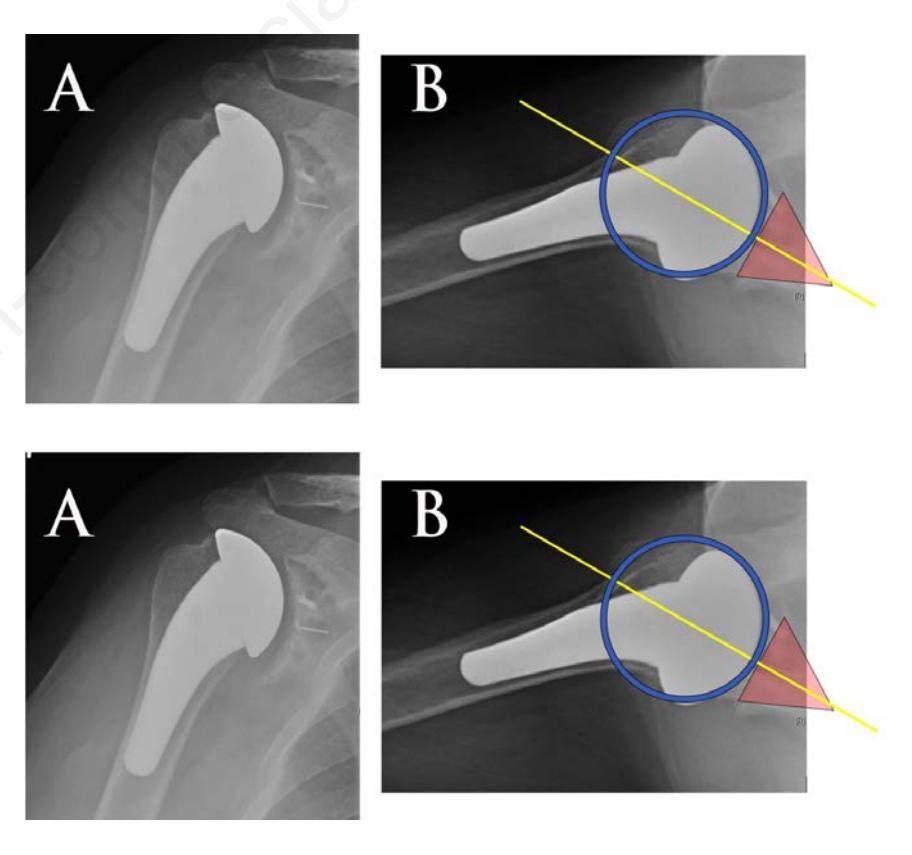
Figure 5. A. Post-operative AP radiograph at one year post surgery shows the total shoulder replacement. B. Axillary lateral radiograph shows the humeral head is well centered on the glenoid with no anterior subluxation detected.
